Glasgow City Council

# Linn Park, Glasgow

Rock Slope Geotechnical Assessment and Remedial Options  
Appraisal Report

372568-01 (01)

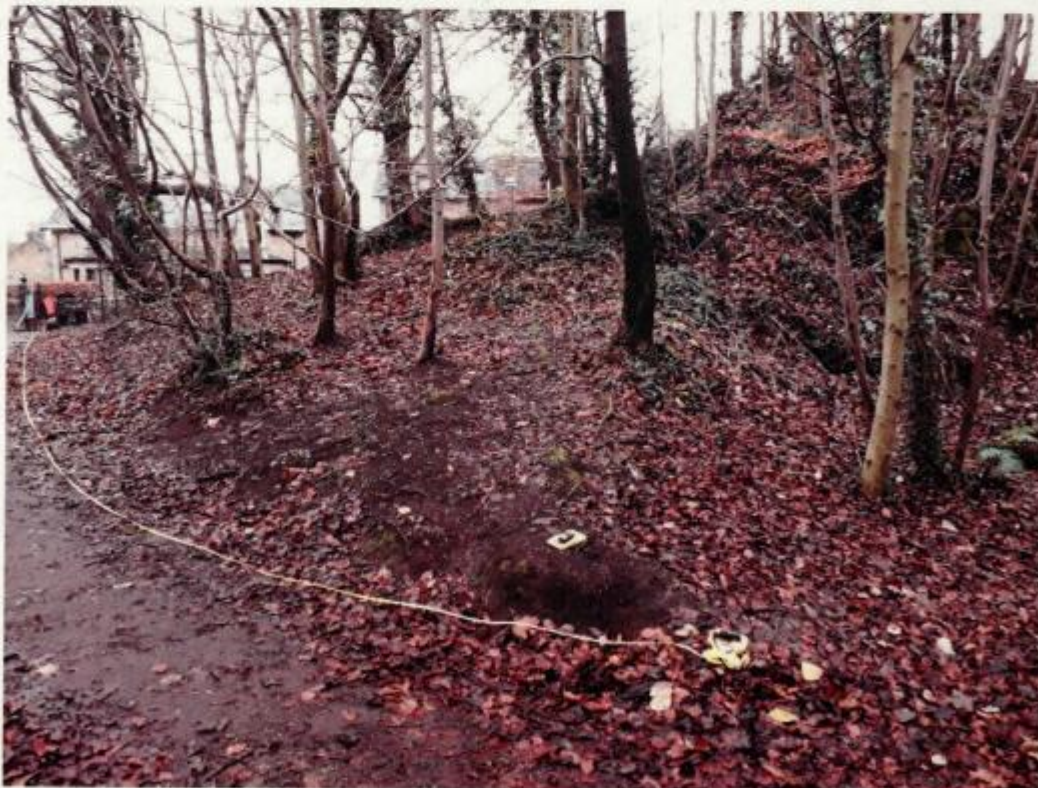
No evidence of instability was observed in this section. Two rock blocks of maximum dimensions 440 mm x 300 mm x 370 mm were present near the toe of the slope adjacent to the path, but there was no evidence that these had fallen and are likely to be blocks that have historically been placed there.

**Figure 4a: General view of Chainage 0 m to 30 m**

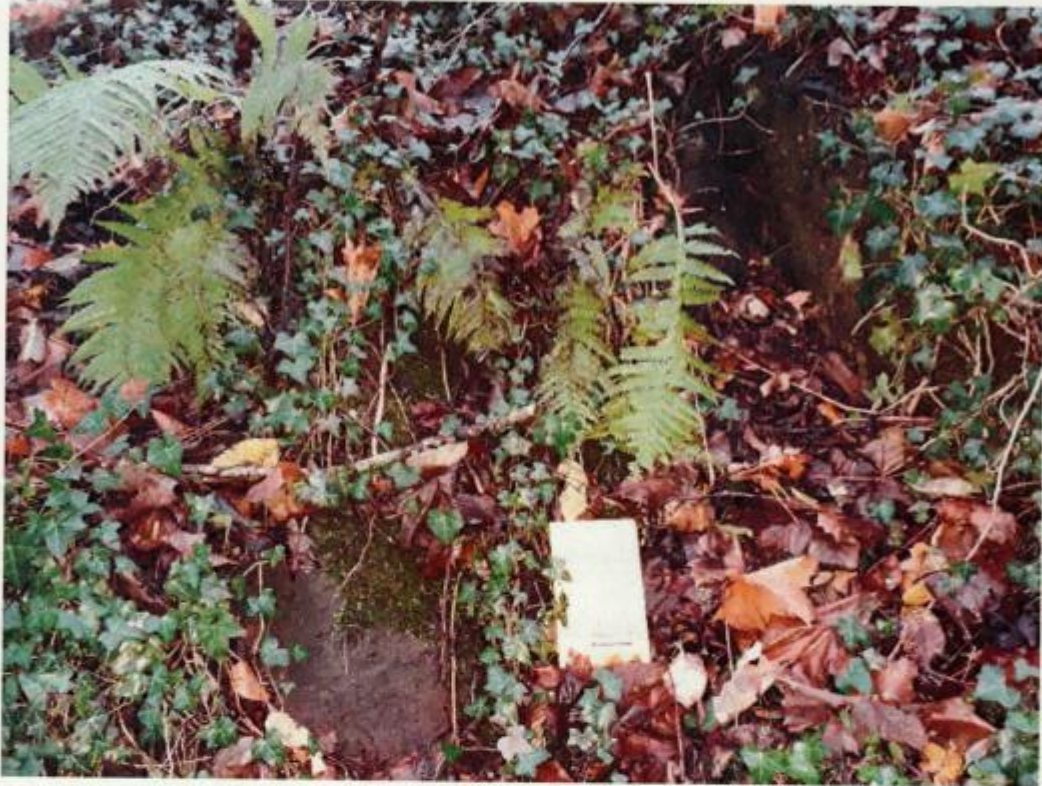
**Figure 4b: Jointed rock exposure near the crest of chainage 15 m**

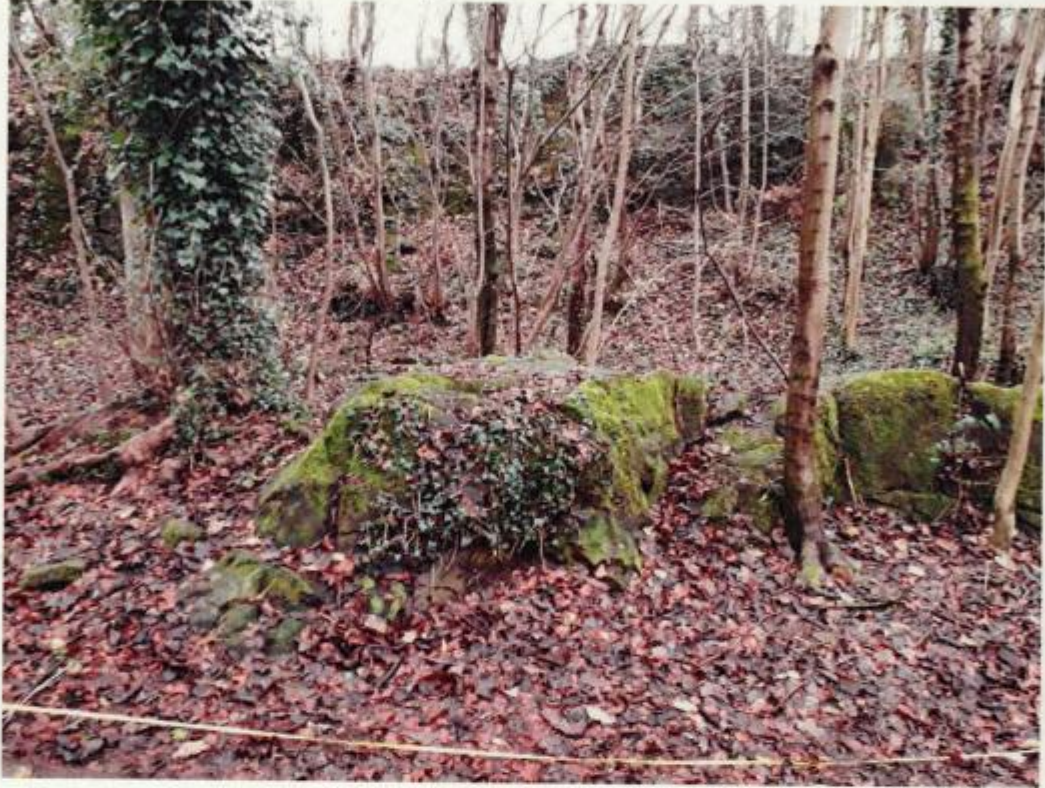
The lower part of the slope is 2 m to 3 m in height, stands at  $40^\circ$ , and is covered by soil and vegetation. It is not clear whether this is a debris slope of spalled rock as it is completely obscured.

**Figure 5a: General view of chainage 30 m to 77 m**

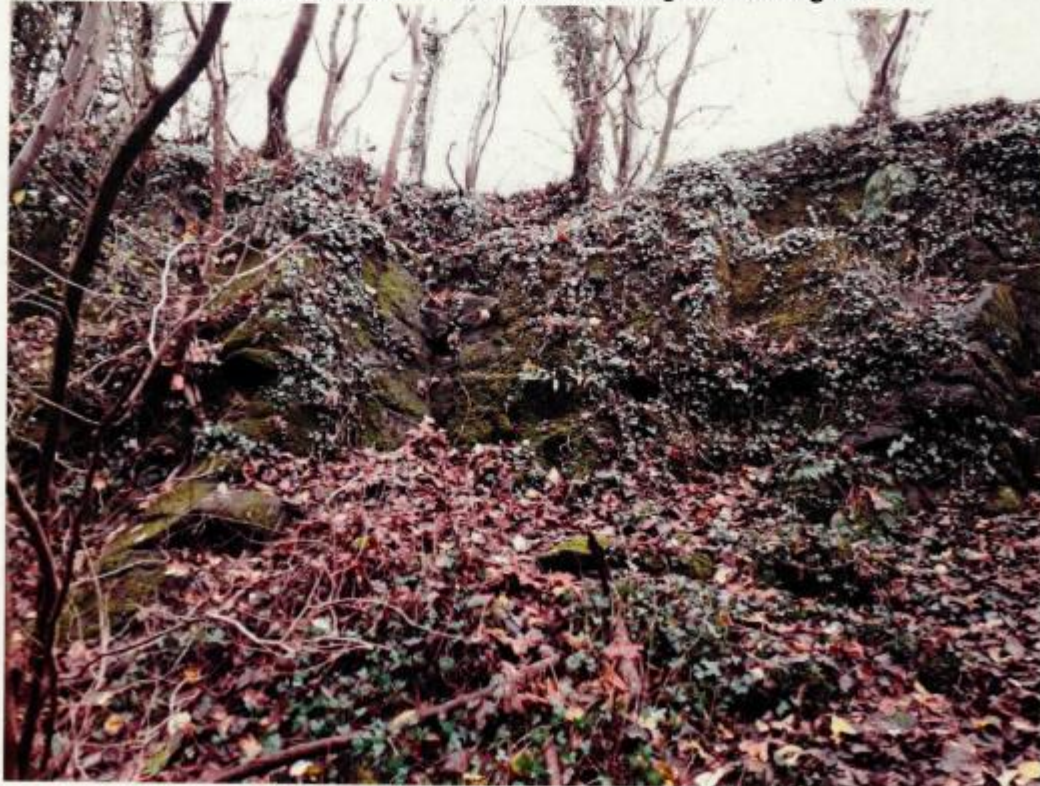
**Figure 5b: Moss and ivy covered well-jointed rock crags at chainage 55 m**

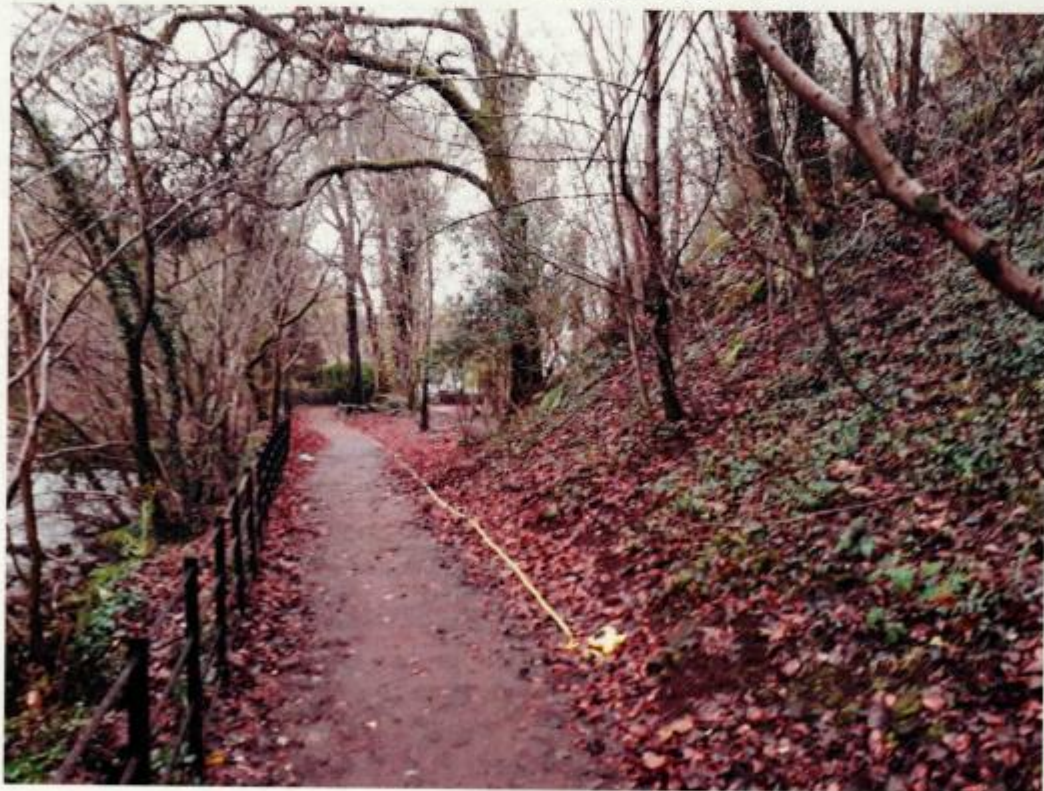
**Figure 6a: General view of lower slope at chainages 77 m to 90 m**

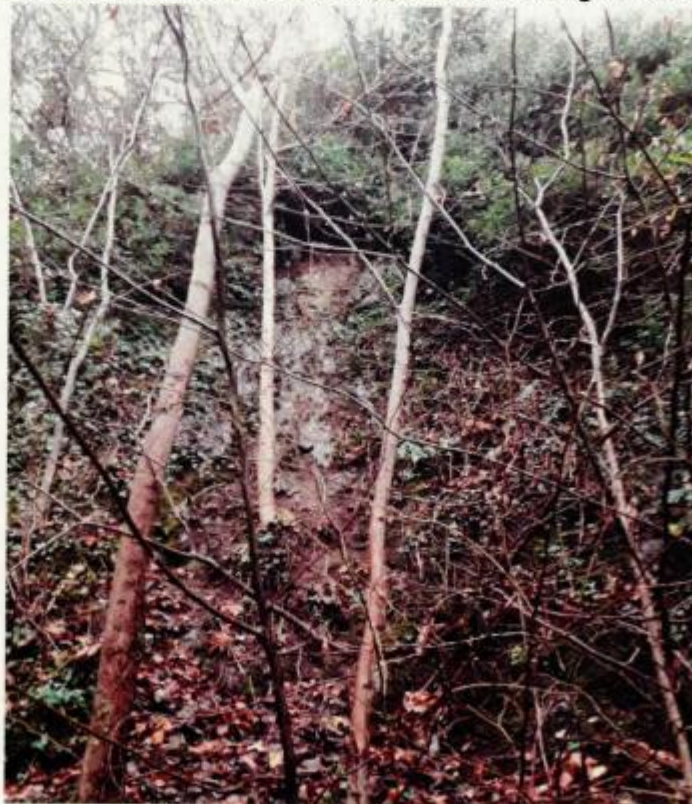
A 4 m to 5 m high failure scar is present on the rock face above the lower slope at chainage 115 m (**Figure 7b**). The failure scar is formed from intersecting planar joint surfaces dipping very steeply (approximately 70°) out of the face. This is the site from which the recent rock falls have occurred. Two large rocks of maximum dimensions 600 mm x 450 mm x 350 mm were present on the footpath at the time of the inspection. It is not clear whether these were further rock falls or uncleared remnants of the earlier rock fall.

**Figure 7b: Recent failure scar on intersecting joints at chainage 115 m**

| Chainage | Length (m) | Slope characteristics | Hazard | Distance from hazard to receptor (footpath) | Qualitative risk rating | Reasoning for risk level |
|---|---|---|---|---|---|---|
| 90 - 135 | 45 | 3m high 50° slope with prominent steep rock crags above. Area of failure. | | Approx. 2.6 m down 50° slope | HIGH | Evidence of instability & effectively no stand-off |

| Applicable to | Remedial options | Advantages | Disadvantages | Buildability | Estimated cost and timescale |
|---|---|---|---|---|---|
| Chainages 77m to 135m | <b>Containment:</b><br>Install a passive mesh system (drapery) on the rock face | Mesh curtain allows material to fail but contains it behind the mesh (breaks the link between hazard and receptor) | Requires initial de-vegetation and scaling of the rock face to be protected by rope-access specialists | Restricted access to toe along footpath and at slope crest<br><br>No access for heavy drilling plant to drill crest and toe anchors | |

| Applicable to | Remedial options | Advantages | Disadvantages | Buildability | Estimated cost and timescale |
|---|---|---|---|---|---|
| | <b>Containment:</b><br>Install a rock fall catch fence at the toe of the slope adjacent to the footpath | Catch fence allows material to fail but contains it behind the fence (breaks the link between hazard and receptor)<br><br>No initial de-vegetation and scaling of the rock face required<br><br>Easy access for maintenance | Requires maintenance visits (approx. every 2 - 5 years dependant on conditions, or when rock fall is reported to have occurred) to remove material caught behind the fence<br><br>Site users may perceive risk as material fails from the face/negative PR | Access only required to toe of slope.<br><br>Standard small plant can be used to drill fence post anchors. | |
| | <b>Reinforcement:</b><br>Install an active reinforced mesh system on the rock face | Rock dowels and tensioned mesh prevent material from failing from the rock face and retains it in situ (removes hazard) | Requires initial de-vegetation and scaling of the rock face to be protected | Restricted access to toe along footpath and at slope crest<br><br>No access for heavy drilling plant | |

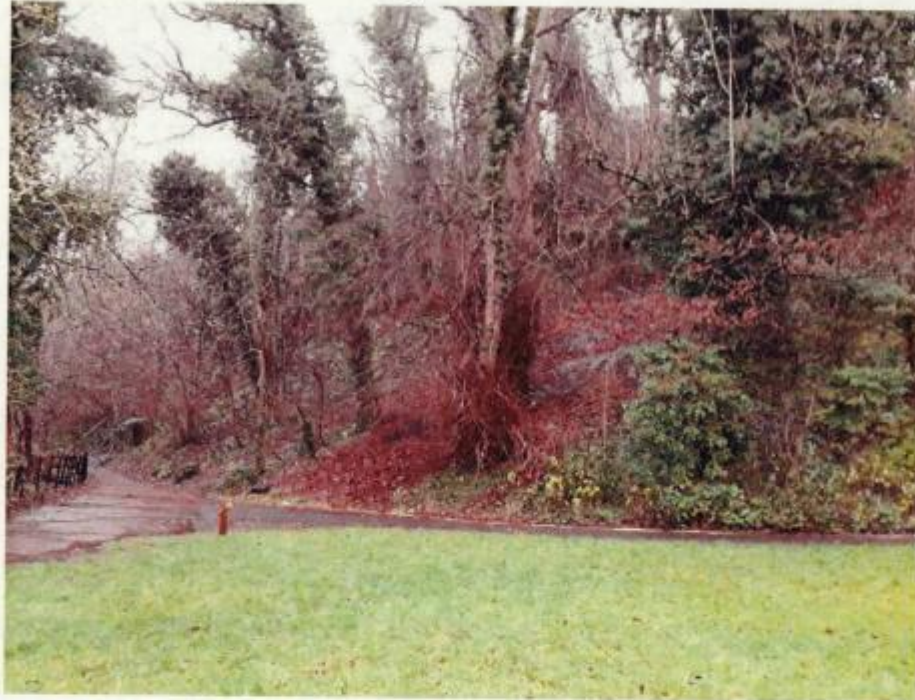
Figure 8b: View of slopes at chainage 170 m

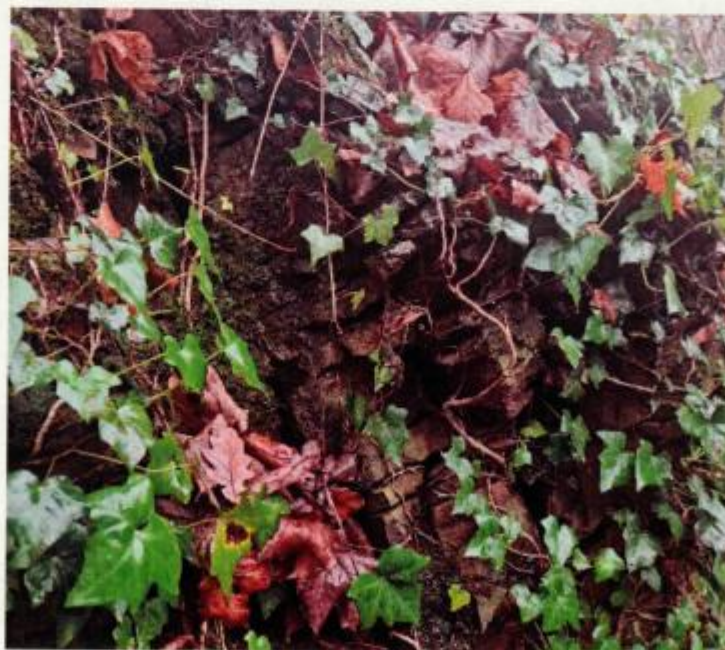
Towards the crest of the slope transverse joints have been exploited by weathering to form loose, open fractures, with an increased fracture frequency and close spacing (**Figure 13**).

**Figure 13: Open close spaced transverse jointing of rock columns at crest of slope**

The analysis clearly shows the dip of the joints is well above the friction angle of the sliding plane. Only joint set 2 (dipping WSW) marginally falls within the sliding instability field. Therefore, it is considered that sliding is unlikely to be a significant failure mechanism at the site. Notwithstanding the above, the exposures demonstrate that given the appropriate orientations, small-scale sliding of loosened column masses may be feasible (e.g. **Figure 13**).
