Glasgow City Council

# Linn Park, Glasgow

Rock Slope Geotechnical Assessment and Remedial Options  
Appraisal Report

372568-01 (01)

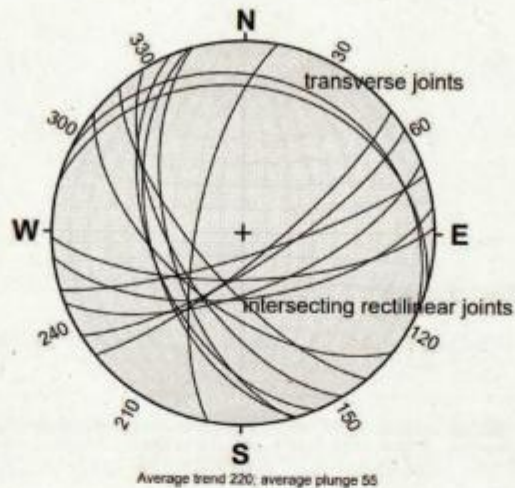
**Figure 12: Stereographic projection displaying the discontinuity sets present across the site**

A summary of the discontinuity sets and intersections are shown as a lower hemisphere equal area stereographic projection in **Figure 12**.

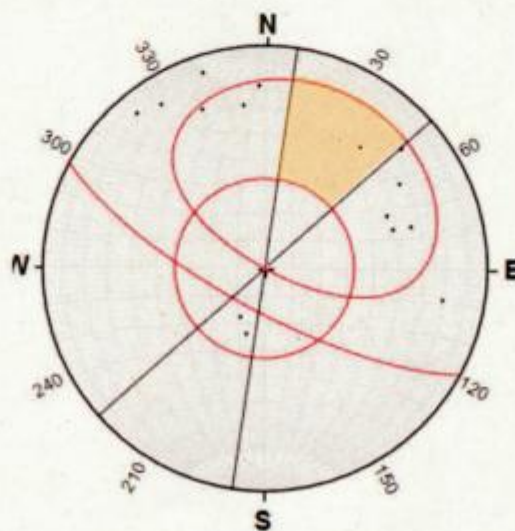
### 4.2 Plane instability

The analysis clearly shows the dip of the joints is well above the friction angle of the sliding plane. Only joint set 2 (dipping WSW) marginally falls within the sliding instability field. Therefore, it is considered that sliding is unlikely to be a significant failure mechanism at the site. Notwithstanding the above, the exposures demonstrate that given the appropriate orientations, small-scale sliding of loosened column masses may be feasible (e.g. **Figure 13**).

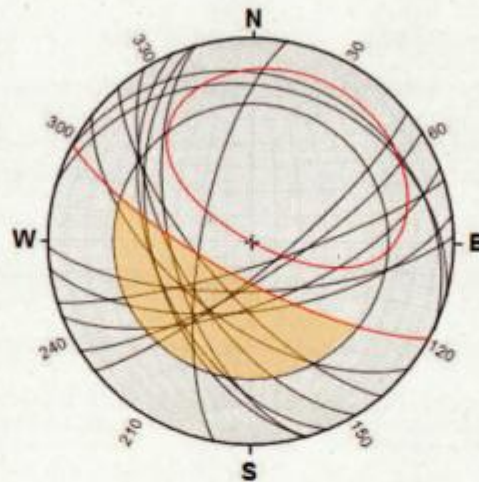
### 4.3 Wedge instability

The kinematic analysis clearly shows that the rectilinear joints intersect within the critical failure field. Wedge failure is therefore viable. Indeed, observations of the failure surface at chainage 115 m indicate that these steeply dipping intersecting joints have formed the failure surface for the recent rock fall events. Elsewhere, apparent historic failures may be evidenced by residual edge material constrained between the intersection joints (e.g. Figure 11).
